The excavation in the Roman *castellum* of Énlaka/Inlăceni in 2022-2023

VISY Zsolt¹

Keywords: Roman limes, castellum, porta praetoria, porta principalis dextra, gate towers, defensive trenches

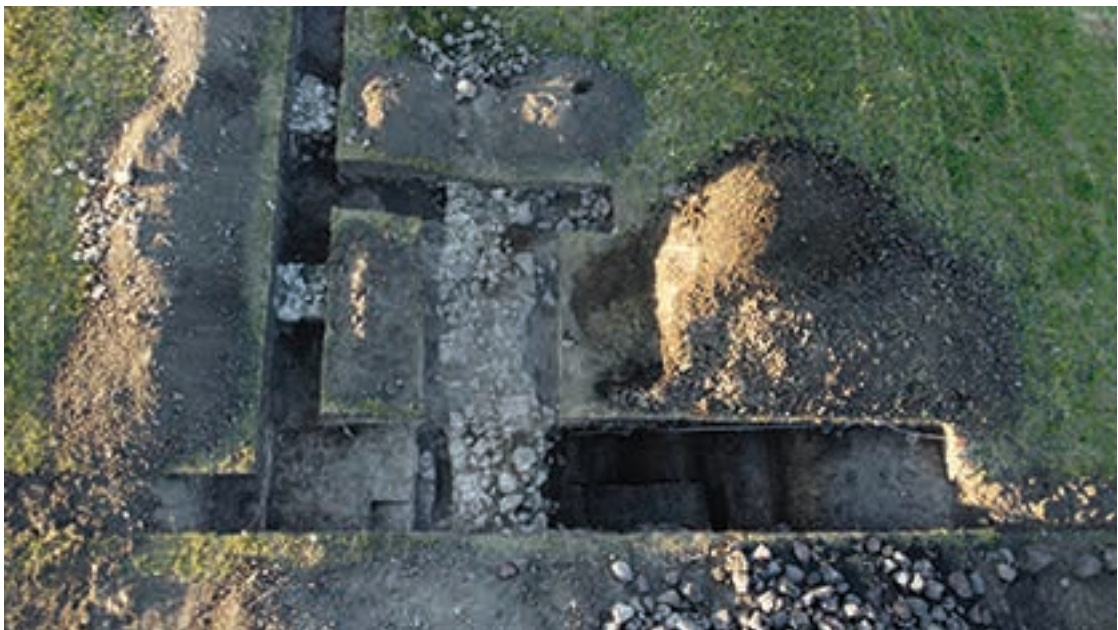
Fig. 5. The wall of the *castellum* and the northern gate tower of the *porta praetoria*

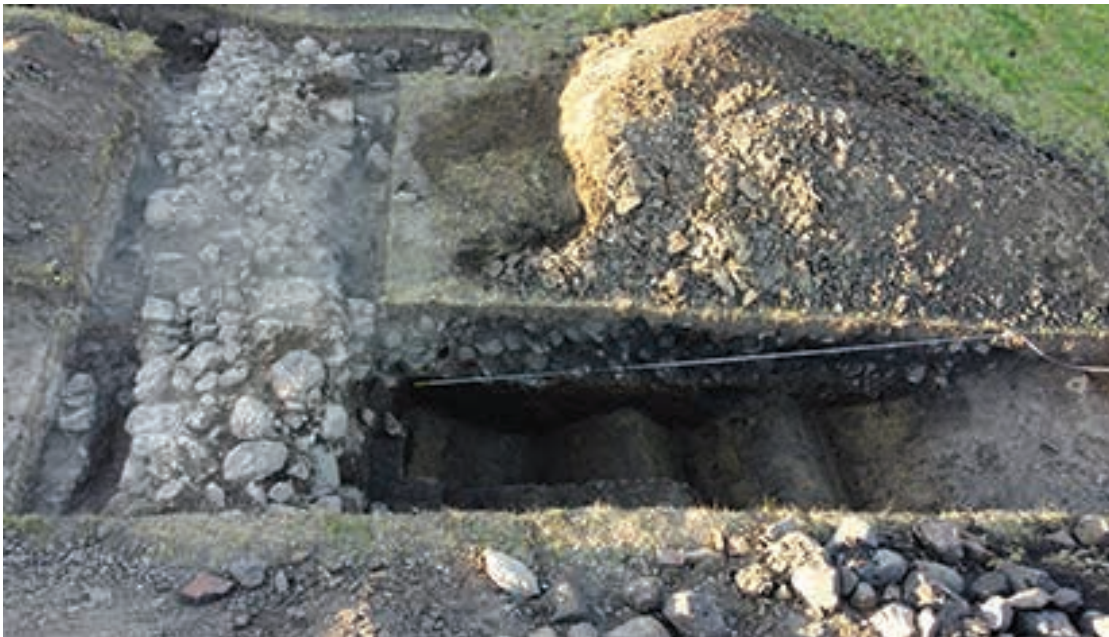
Fig. 9. The wall of the *castellum* and defensive trenches

one and a half meters out is a consequence of the fact that the wall of the tower jumped out of the former wall plane. On the basis of this consideration – although no dated finds have been recovered from them, Trench II can be linked to the stone fort in 149 and Trench III to the fort restored at the beginning of the third century, presumably during the time of Caracalla, when the gate towers were built (Fig. 9-10).

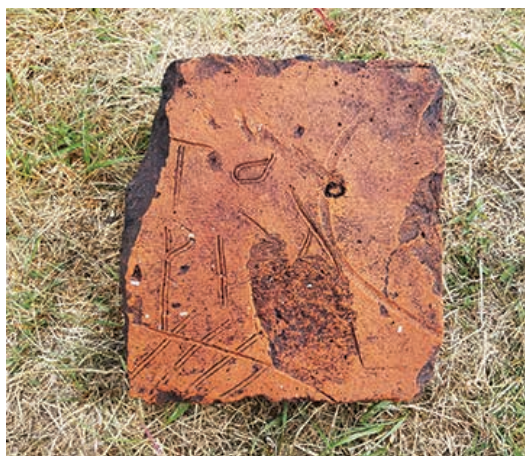
Fig. 11. Part of a *later* with graffito

During the excavation, few finds were unearthed, mainly smaller-larger vessel fragments. A great many *tegulas* and fragments of *imbrex* lay in the crumbs. To highlight is a fragmentary *later* with a detail of a scratched two-line inscription [...]TO / [...]PILA (Fig. 11).

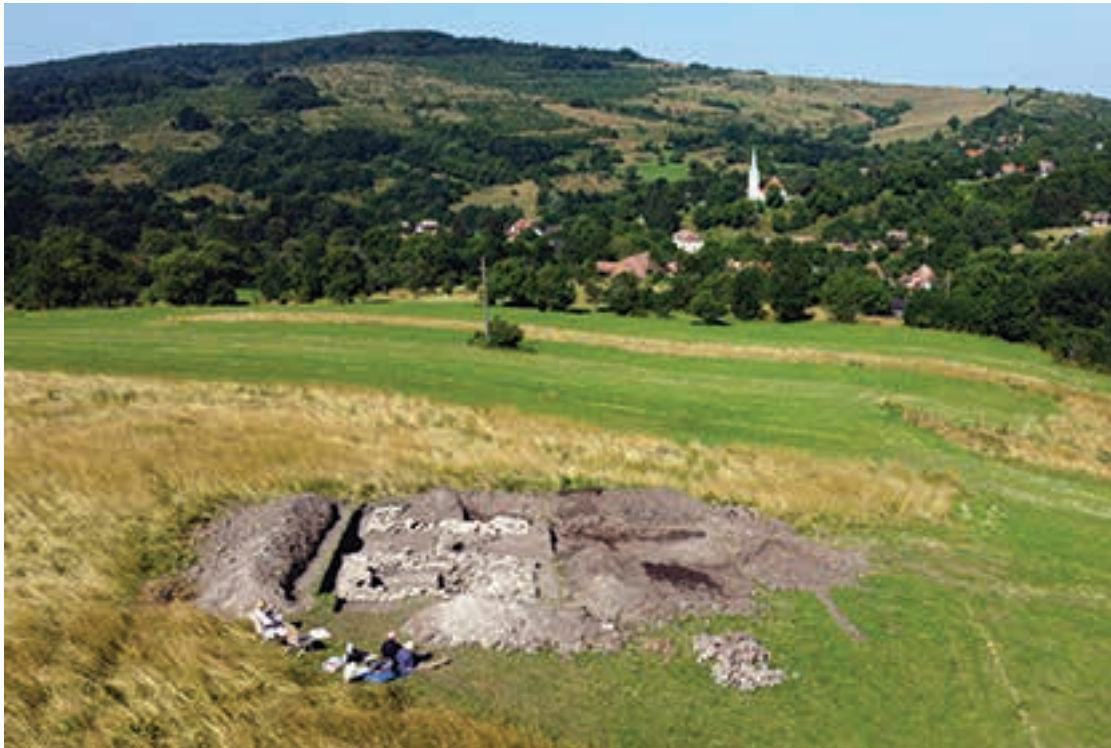
Fig. 12. Ěnlaka/Inlăceni *castellum*, *porta principalis dextra* from the east

In 2023, excavation was again carried out at the north side gate, the purpose of which was to unravel the two gate towers and the defensive ditch in front of them on the eastern side of the research trench two years earlier (Fig. 12). Based on the geophysical survey, the two towers appeared directly below the surface.

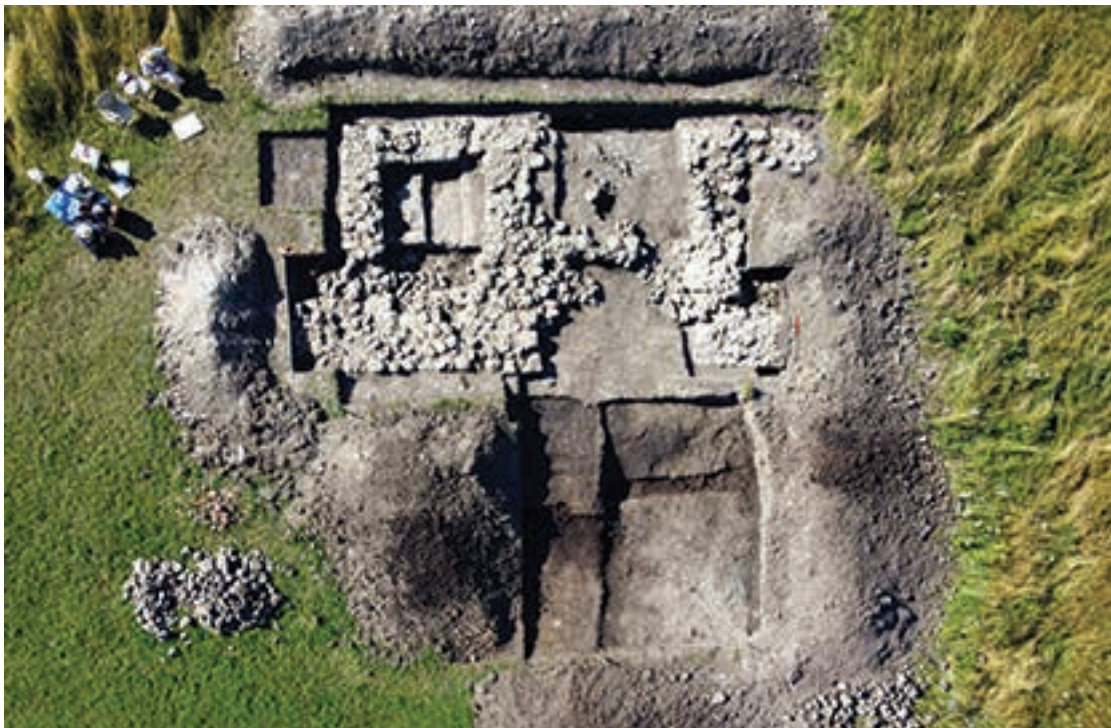
Fig. 13. Top view of Ěnlaka/Inlăceni *castellum*, *porta principalis dextra*.

- It was possible to excavate both gate towers in their entirety with the road between them and the ditch ahead of them (Fig. 13).

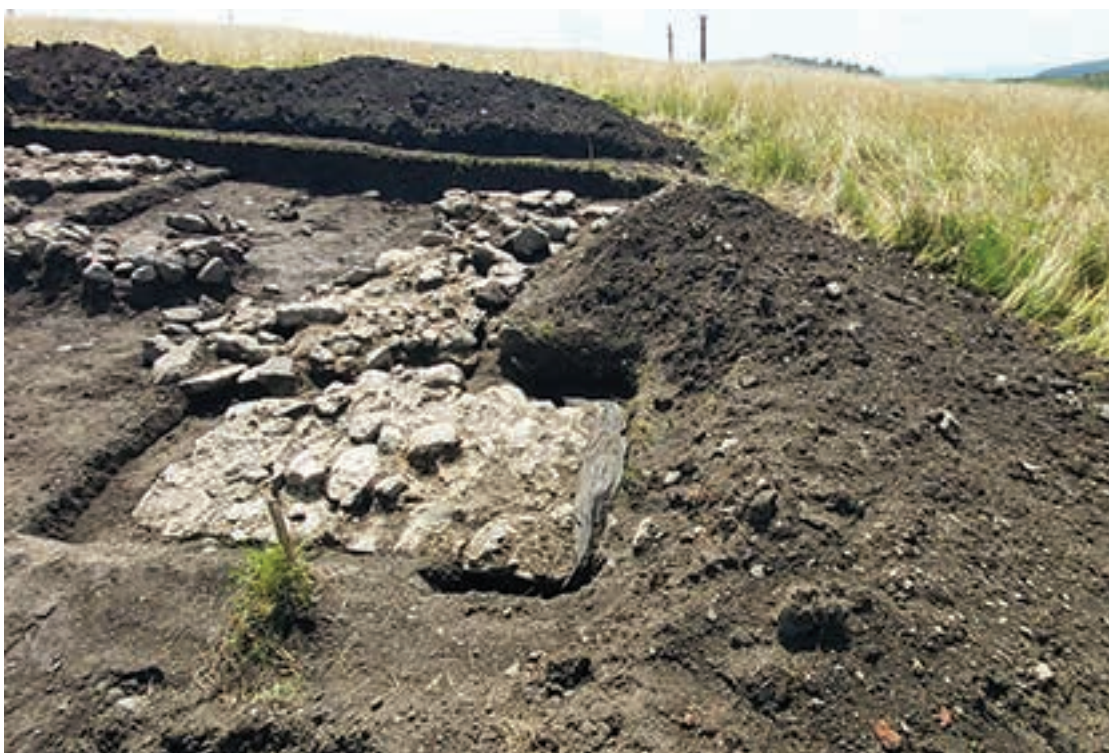
Fig. 14. Énlaka/Inlăceni *castellum*, *porta principalis dextra*, western gate tower from north

- The length of the western tower is 5.95 m, and its width, excavated in 2023, is 3.30 m (Fig. 14). The total width of the tower, including the strip excavated in 2021, is 4.7 m. The width of the wall is 1.40 m on the outside, 1.2 m on the east side and 0.9 m on the south side. Two pillars are attached to its eastern side. One at the southern edge: 0.3 x 1 m, the other at 3.1 m: 0.2 x 0.9 m. Together with the opposite pillars, these supported the bridge over the doorway.

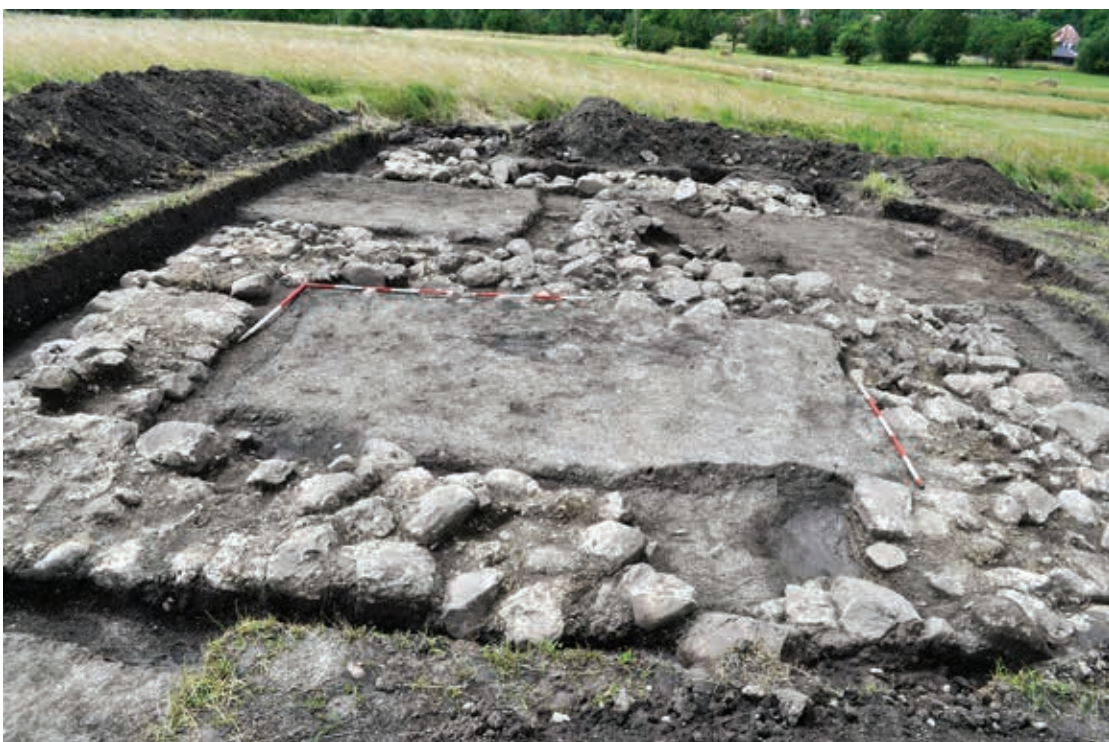
Fig. 15. Énlaka/Inlăceni *castellum*, *porta principalis dextra*, eastern gate tower from east

- The eastern tower is not quite regular (Fig. 15). Its length is 6.2 m on the west side and 5.9 m on the east side. Its width is 4.7 m. The width of the wall is 1.4 m in the north, 1 m in the west, 0.9-1 m in the east, 0.85 m in the south. On its western side there are two pillars. One fits the southwest corner: 0.3 x 1.4 m, the other is 0.3 x 1 m.

This pillar begins at 3.4 m from the outer edge of the southern wall. The two pillars are exactly opposite the two pillars of the west tower. The cracks in the walls of both towers, caused by ground movement, slightly modified the original size of the towers.

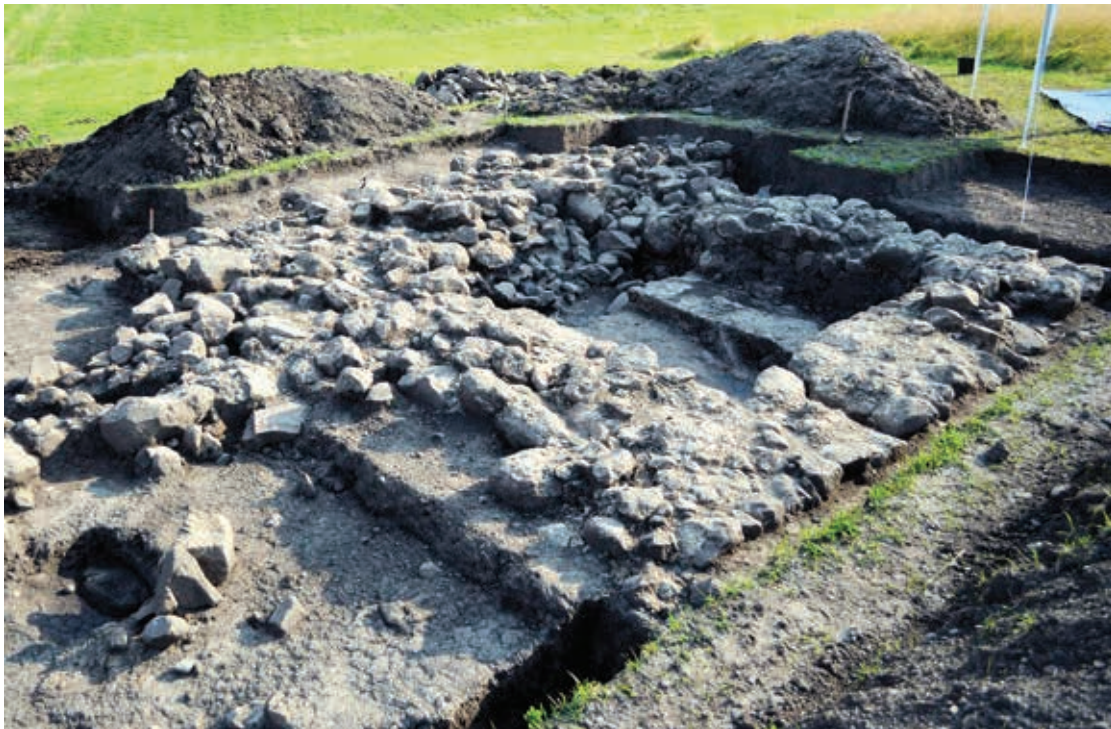
Fig. 16. Énlaka/Inlăceni *castellum*, *porta principalis dextra*, eastern gate tower with pillar from southwest

- Two pillars were attached to the road-side walls of the towers, which held the bridge over the doorway. The gate was in the line of the outer pillars (Fig. 16-17).

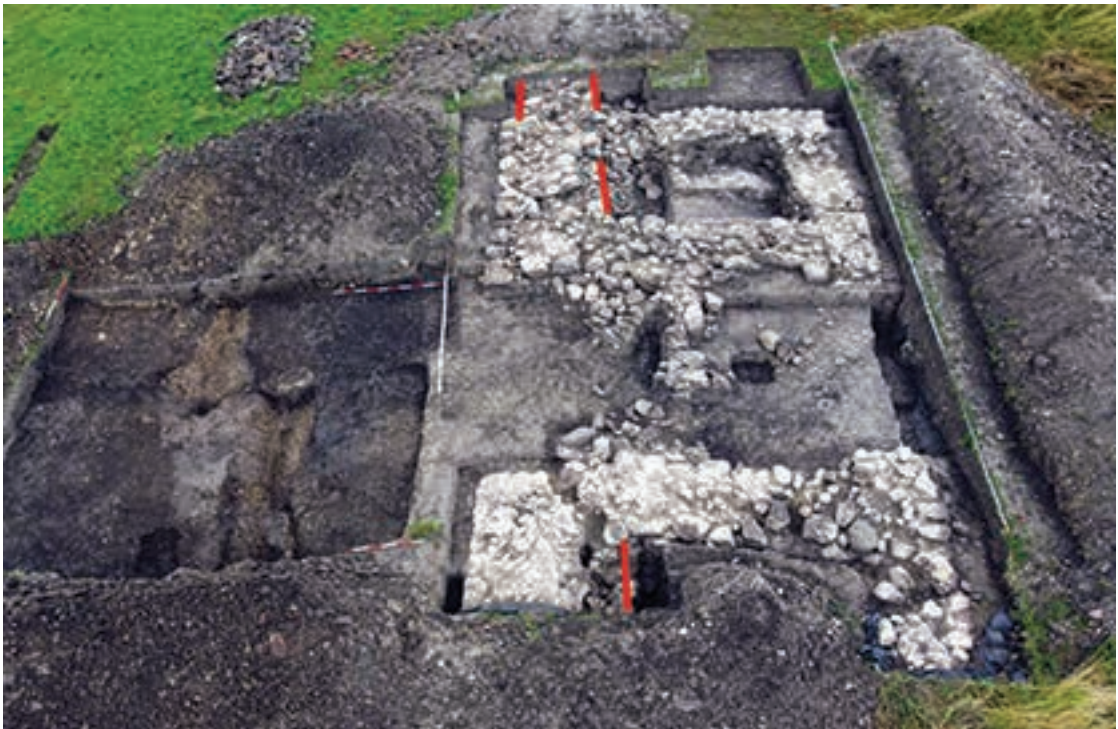
Fig. 18. Énlaka/Inlăceni *castellum*, *porta principalis dextra*, demolished *castellum* wall inside the towers from west

- It is proved that in the period before the towers, the walls of the *castellum* went up to the road. His remains have also been found inside the towers (Fig. 18). According to a building inscription found earlier, the stone fortress was built in AD 149, and a building inscription from the Caracalla period is related to the restoration of the *castellum* and the construction of the towers.

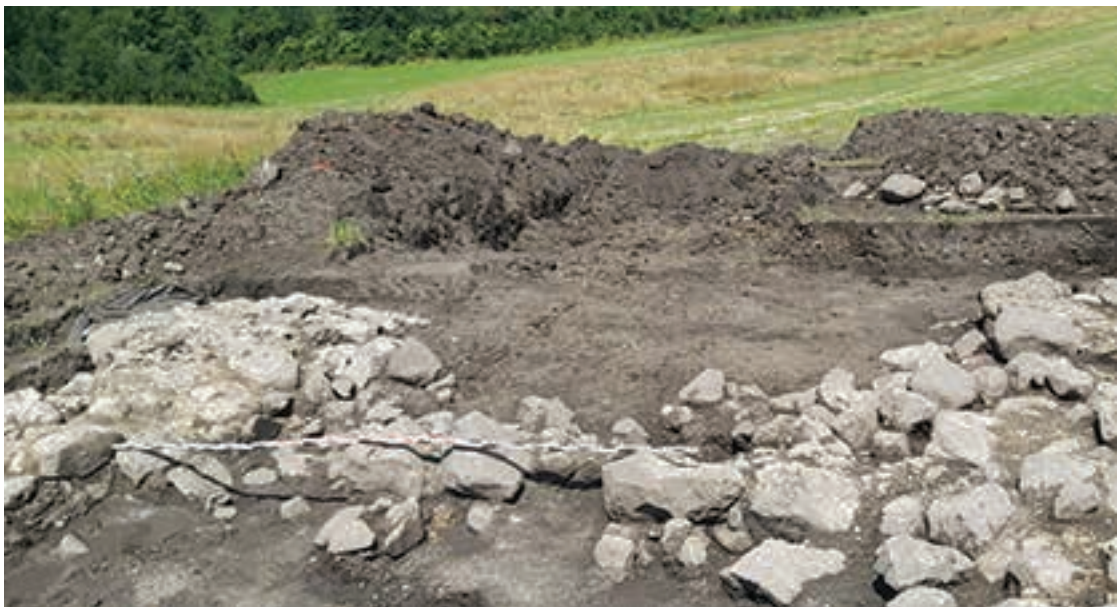
Fig. 19. Énlaka/Inlăceni *castellum*, *porta principalis dextra*, gate walling from the north

- The doorway was blocked later, in the thirties and forties of the 3rd century. The narrow, incomplete stone row of the gate masonry is aligned with the southern edge of the former gate by the pillars in the plane of the gate wings. Its width must have been 0.6 m. The missing stones at its western end may indicate a footgate (Fig. 19).

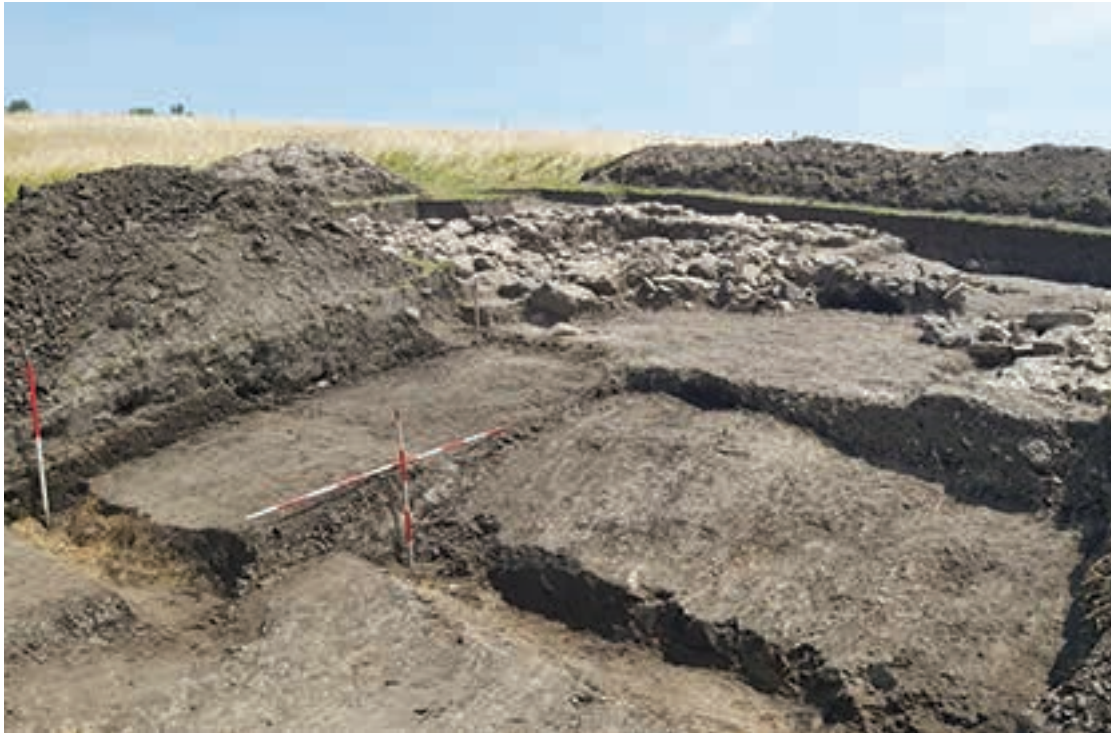
Fig. 20. Énlaka/Inlăceni *castellum*, *porta principalis dextra*, defensive trenches II and III during excavation from the northwest

- Both phases had defensive trenches, the axis of the *fossa* (III) of the Caracalla-era fortress was one and a half meters further out than the previous one (II) (Fig. 20-21). The ditch of the palisade camp (I) was even closer to the stone wall of the *castellum*, partly under the *castellum* and towers, but it was not possible to excavate it.

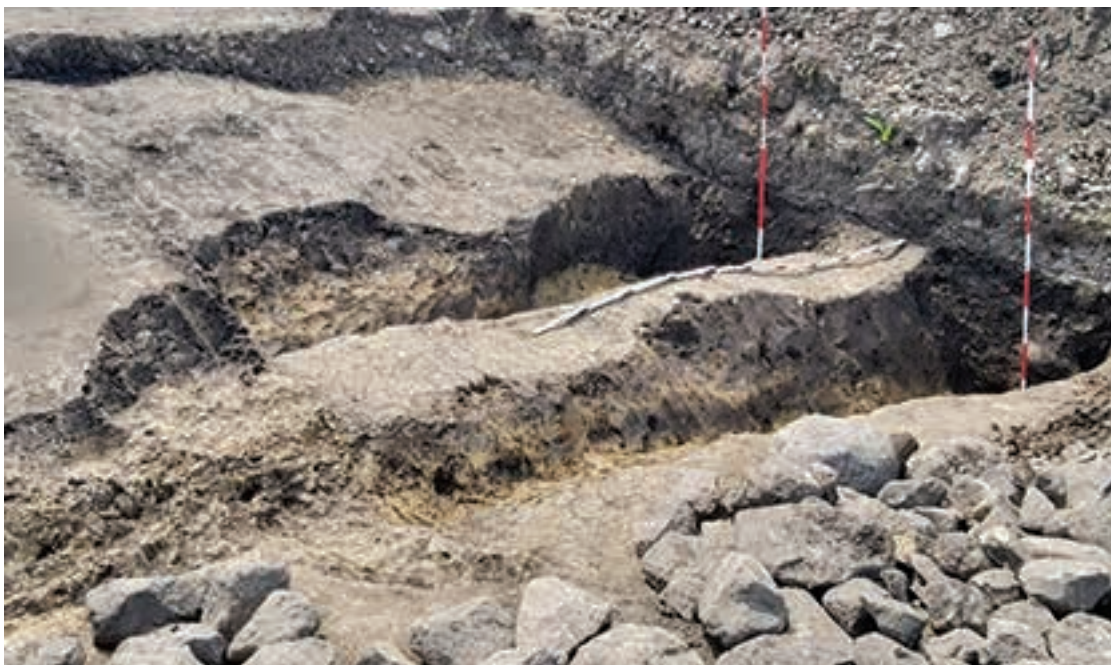
Fig. 21. Énlaka/Inlăceni *castellum*, *porta principalis dextra*, defensive trenches II and III from the north-east

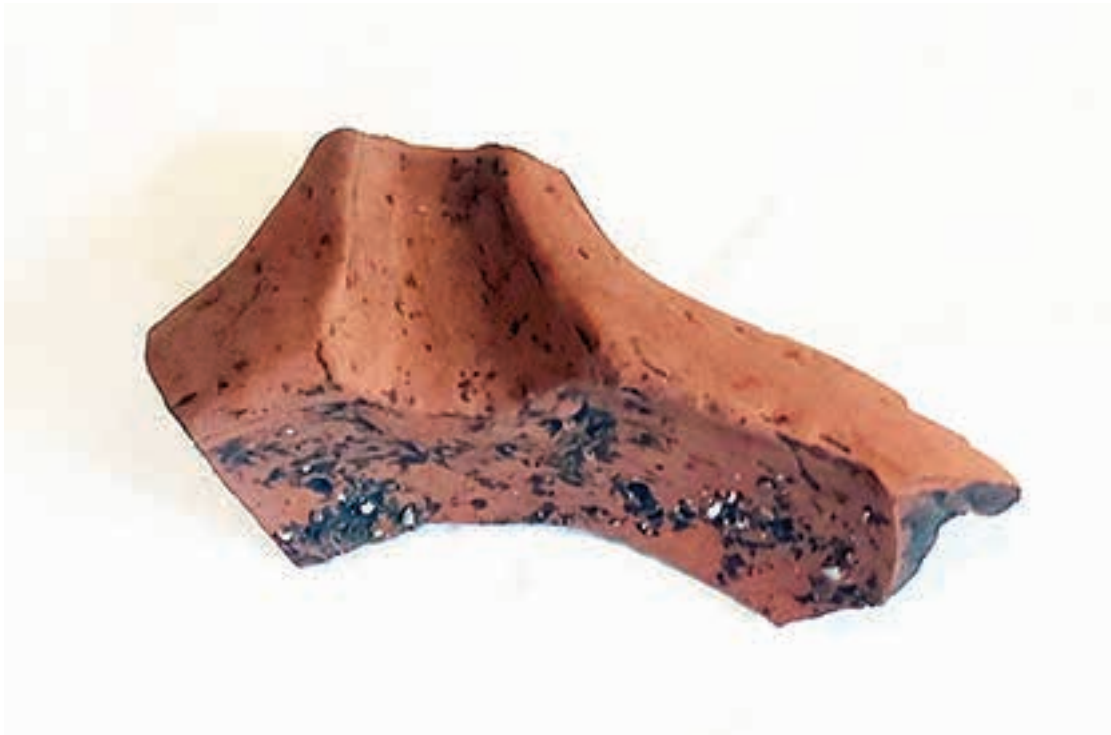
Fig. 23. Énlaka/Inlăceni *castellum*, *porta principalis dextra*, rim fragment of a mortar from ditch II

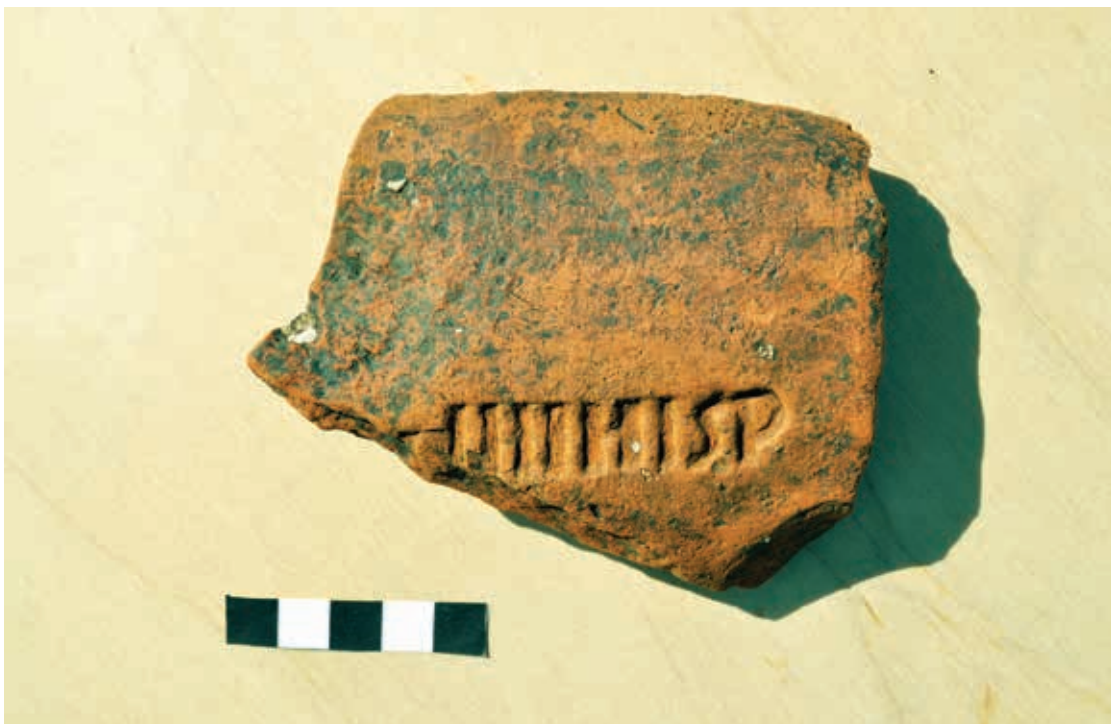
Fig. 24. Énlaka/Inlăceni *castellum*, *porta principalis dextra*, stamped *imbrex* fragment of the *cohors IIII Hispanorum* from ditch III

and during the excavation of defensive ditch III, fragments of some stamped bricks of the *cohors III Hispanorum* were found (Fig. 23-24).
